Yarra LAAP Evaluation - Pedestrians and Cyclists

BEFORE AND AFTER REPORT

EVALUATION OF JOHNSTON STREET/NAPIER STREET INTERSECTION TREATMENTS

- V4
- 19 November 2009

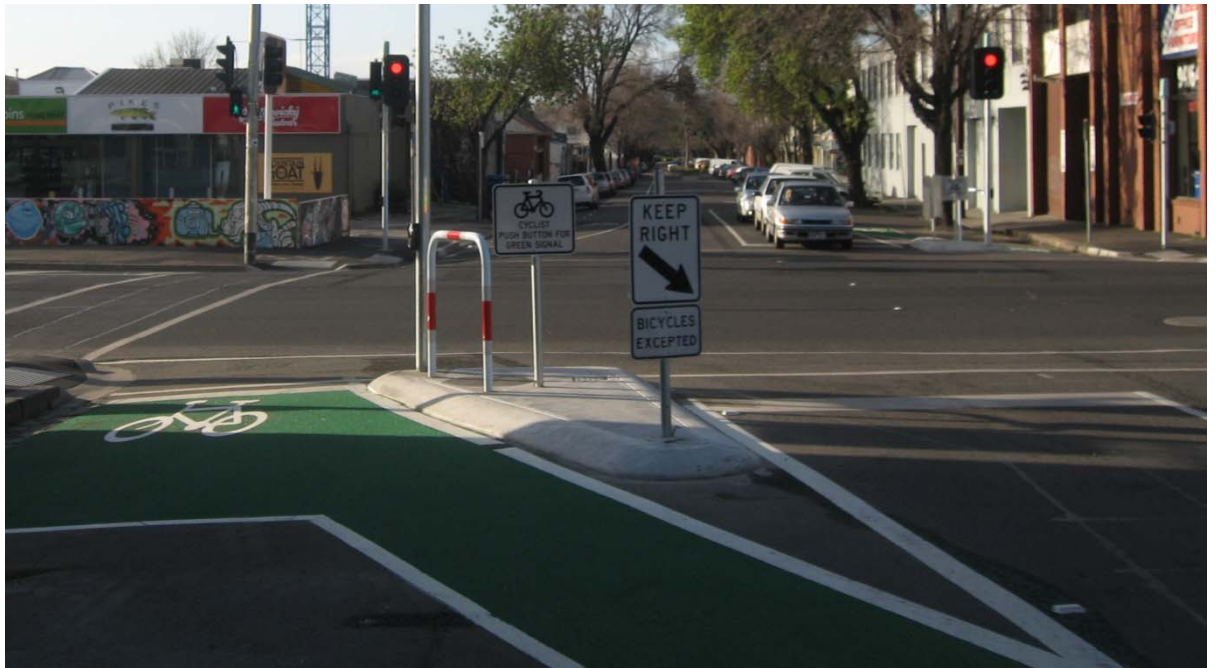
■ **Figure 2 Cyclist call button (looking north)**

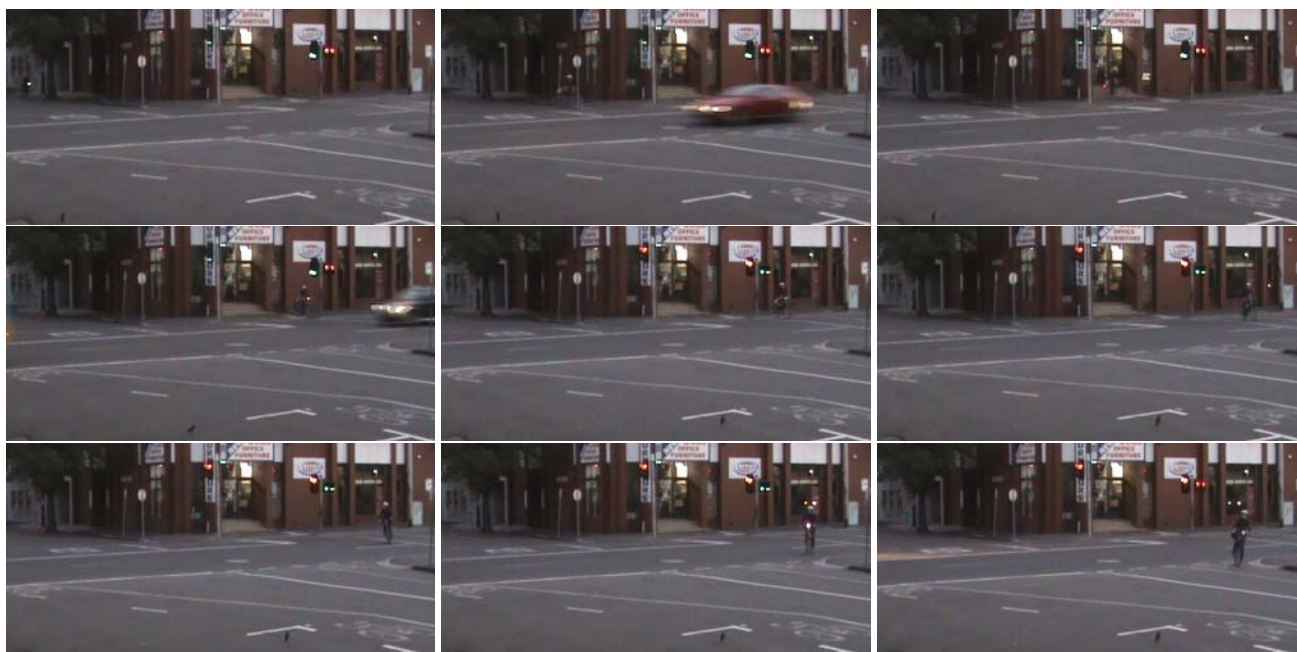
Of the 130 cyclists using the signalised crossing, only 6 cyclists – or 2% – were observed dismounting. Although the crossing had both pedestrian and cyclist displays, cyclists had to ride on the footpath to access the signals, which is technically not legal. There is some uncertainty as to the legality of cyclists riding across pedestrian crossings even when a green cyclist lantern is displayed. It is our understanding that the Victorian Road Rules will be amended in November 2009 to state cyclists must not ride across a pedestrian crossing *unless* a green cyclist lantern is displayed.

- **Figure 7 Southbound cyclists ride from the pedestrian crossing directly to Napier Street**

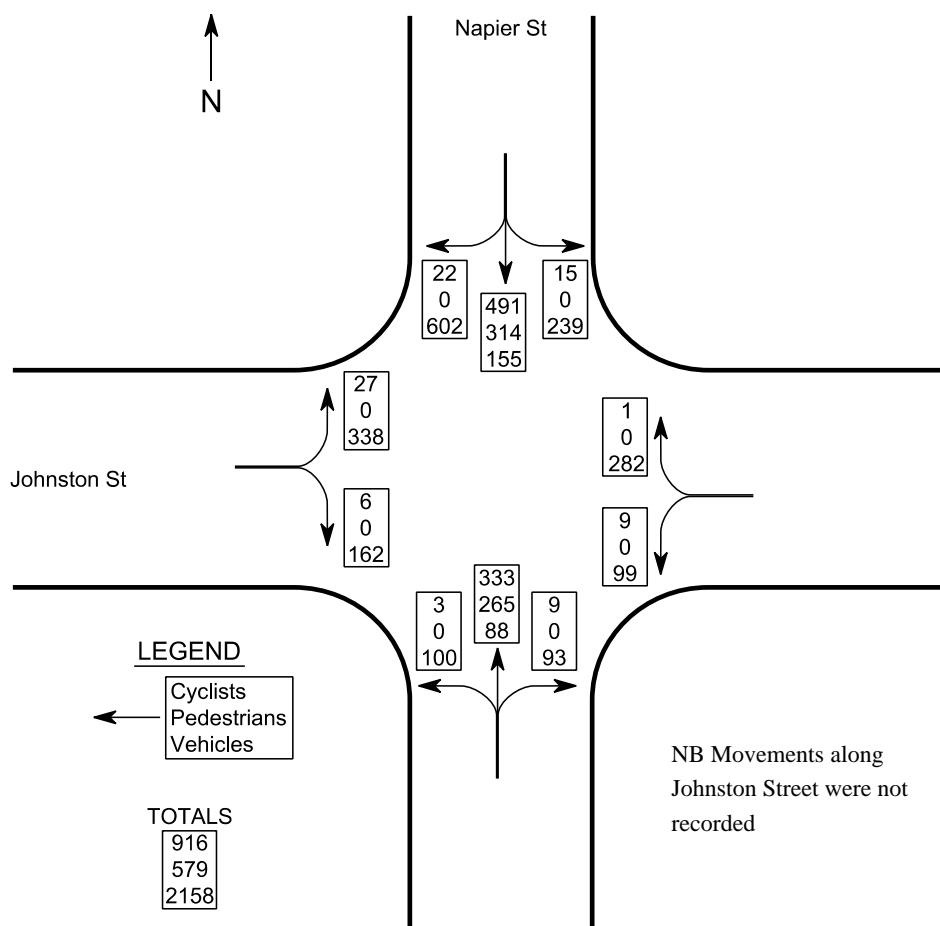
■ **Figure 9 Cyclist, pedestrian and vehicle turning movements after installation of the signals (total number over 6 x 2 hour periods)**

Cyclist volumes were again highest in the AM period, with fewer in the PM period and fewer again during the day. The most popular movement was still southbound along Napier Street (491), followed by northbound along Napier Street (333).

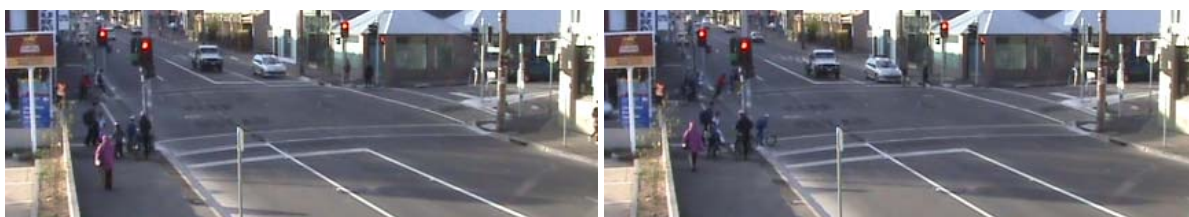
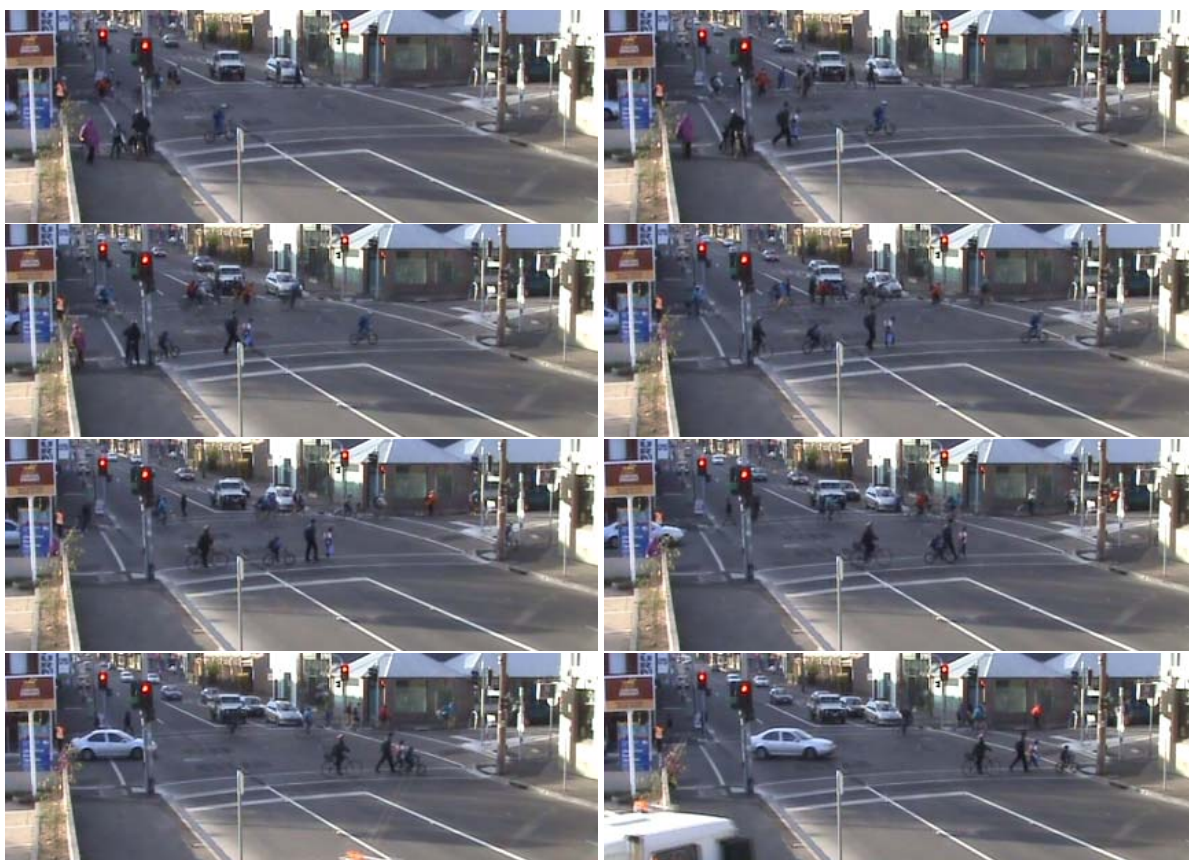
Anecdotal evidence suggests that there was an increase in the number of child cyclists after the intersection was signalised, with one, two or three child cyclists usually riding with an adult cyclist as in Figure 12.

- **Figure 12 Child cyclists with adult cyclist crossing at the intersection (using near side pedestrian crosswalk)**

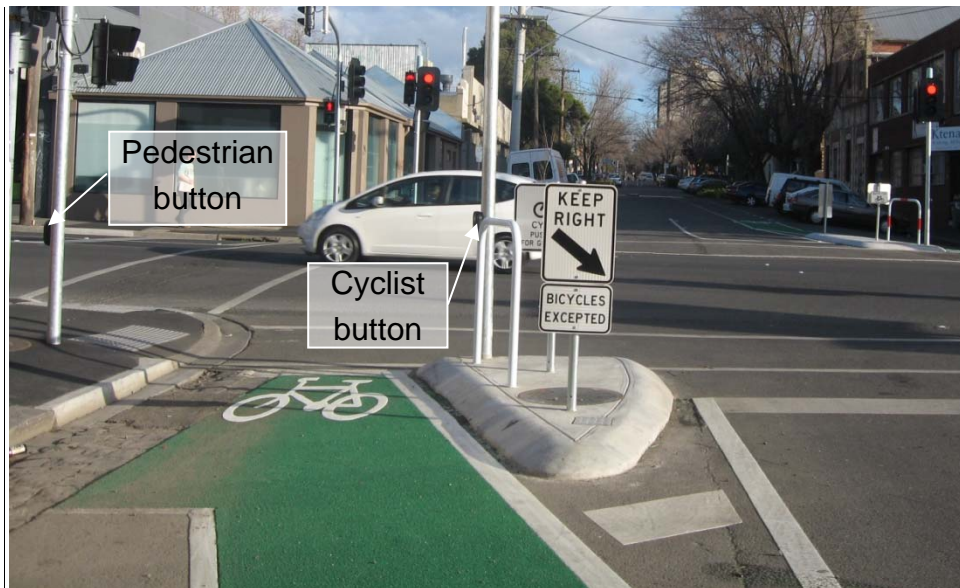
that arrived in the same phase to also press the button. Of those cyclists who were first to arrive at the intersection, 77% travelling southbound and 93% travelling northbound pressed the cyclist button. One cyclist was observed to press the pedestrian button but ride along the road (the pedestrian button for crossing Napier Street is on the left side of the cycle lane as in Figure 14). Despite the clear signage that was installed directing cyclists to ‘push button for green signal’, 15% of cyclists that were first to arrive at the intersection did not use the cyclist push button. Two cyclists pressed both the cyclist and pedestrian buttons. This could be because some cyclists were unaware of how the intersection operated or because they did not think the cyclist button worked (possibly because the reassurance light on the cyclist push button did not light up when pressed).

■ **Figure 14 Some cyclists confused the pedestrian button for the cyclist button**

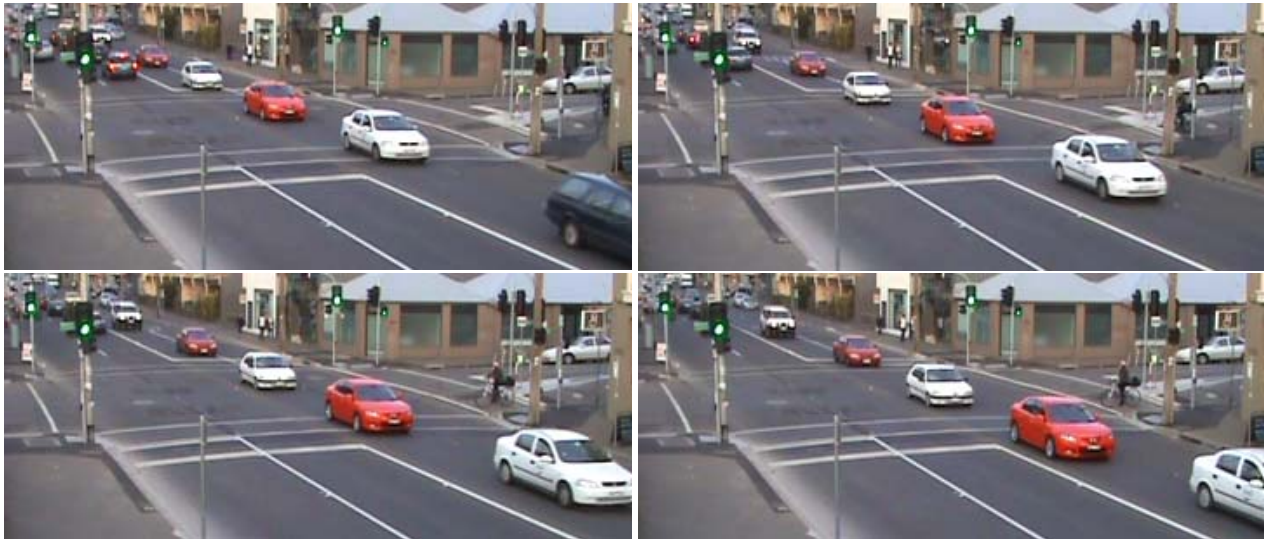
9% of cyclists observed crossed Johnston Street used the pedestrian crosswalk rather than the road. People riding with children were more likely to use the pedestrian crosswalk. Some of these cyclists were performing a hook turn and so the pedestrian crosswalk provided a safe place to wait.

■ **Figure 15 Cyclist stopping over the pedestrian crosswalk**

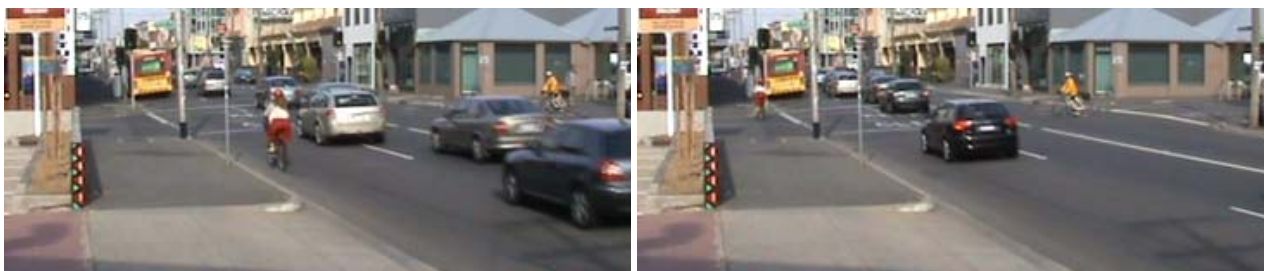
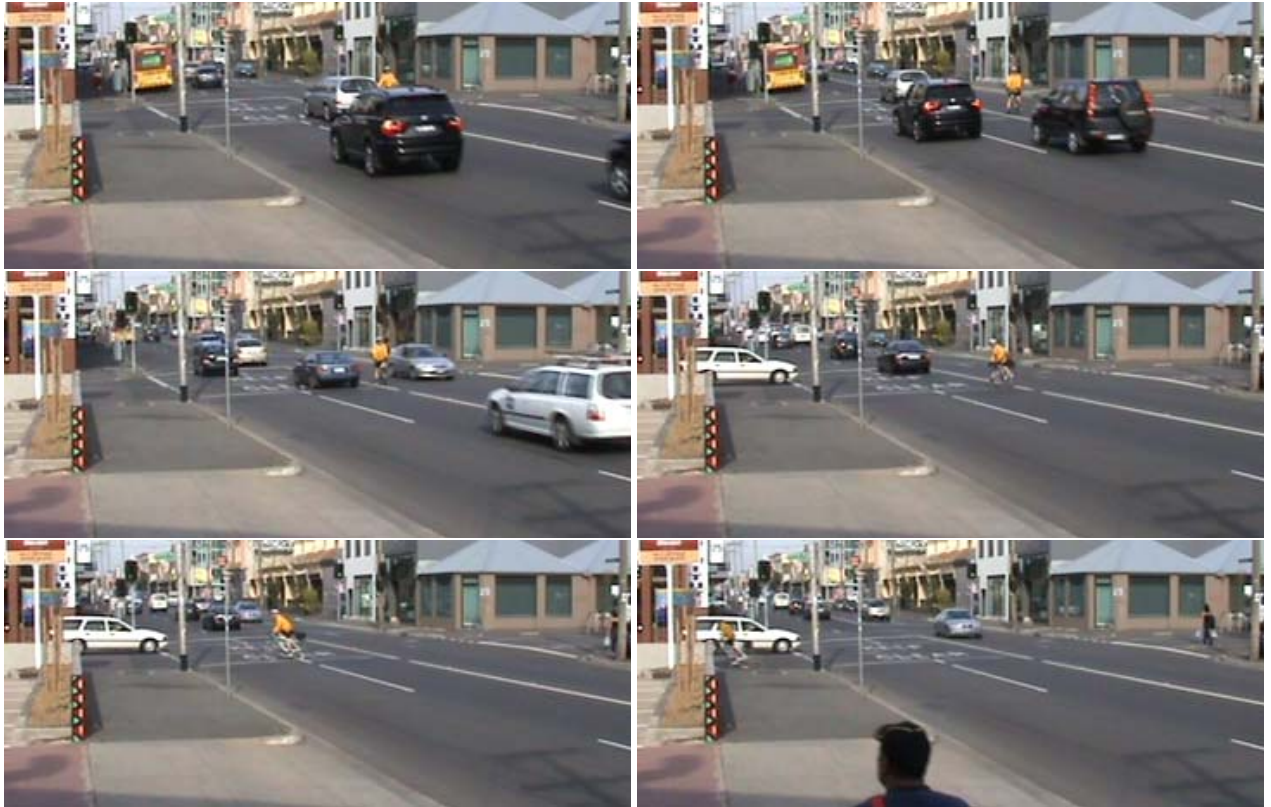
Before signalisation there were some pedestrians and cyclists who ‘propped’ in the middle of Johnston Street when crossing because there was a gap in traffic only in one direction as shown in Figure 16. This could prove very unsafe for cyclists and pedestrians as they could be squeezed into a narrow space with moving traffic on either side of them. After the intersection was signalised, this was not observed again. There were however some cyclists and pedestrians who crossed Johnston Street while facing a red light, and then had to slow until there was a sufficient gap in the Johnston Street traffic.

■ **Figure 16 A cyclist in yellow top stops in the middle of Johnston Street while crossing**

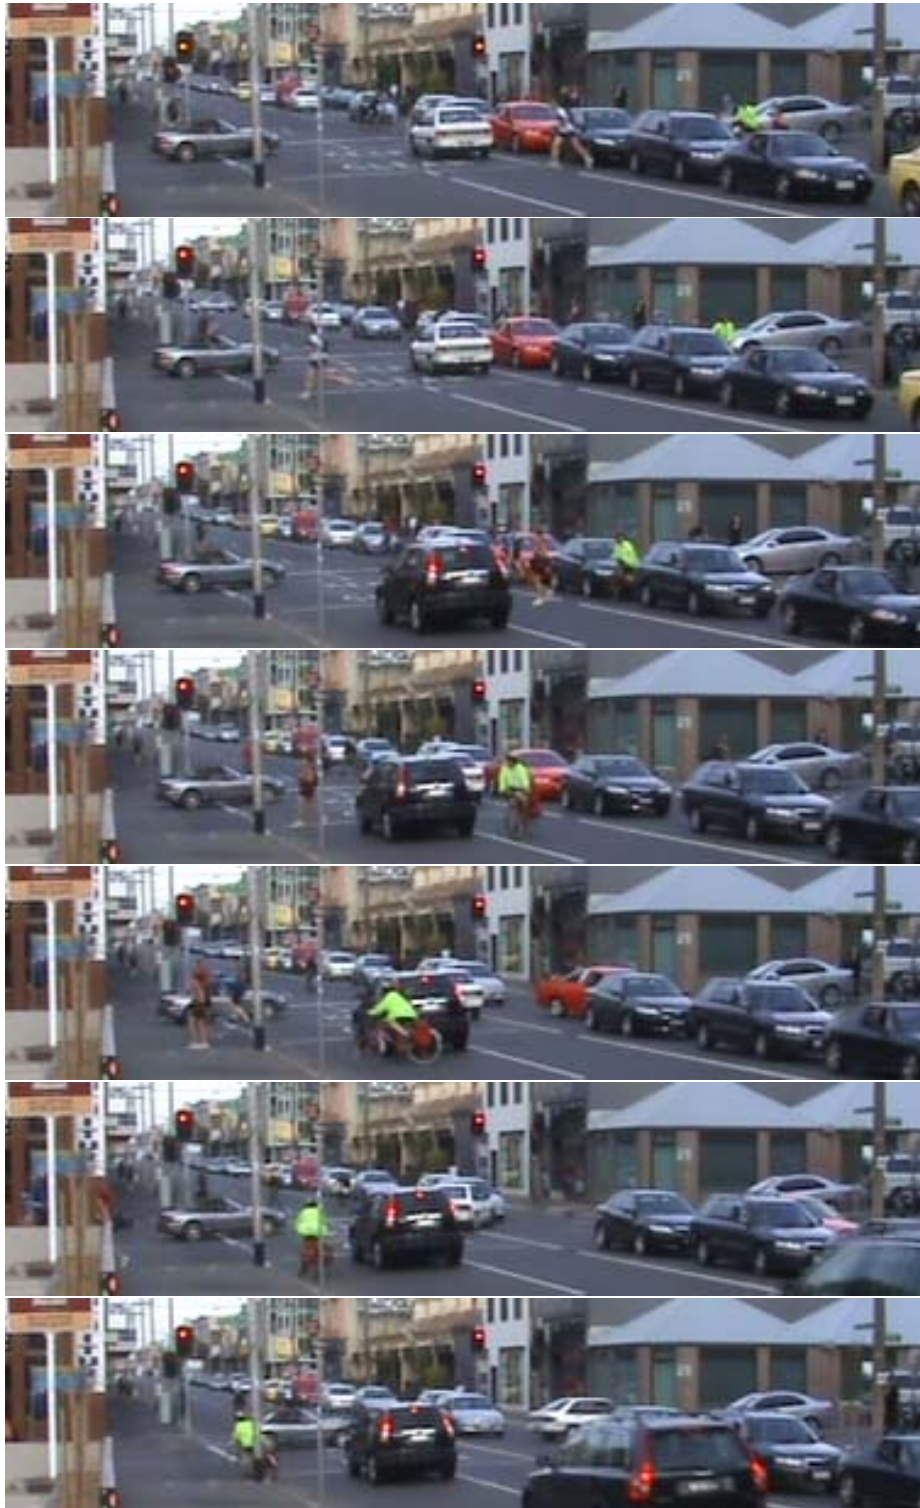
- **Figure 19 Before signalisation: Cyclist (yellow top) and pedestrians (white top and red top) take advantage of the red traffic light**

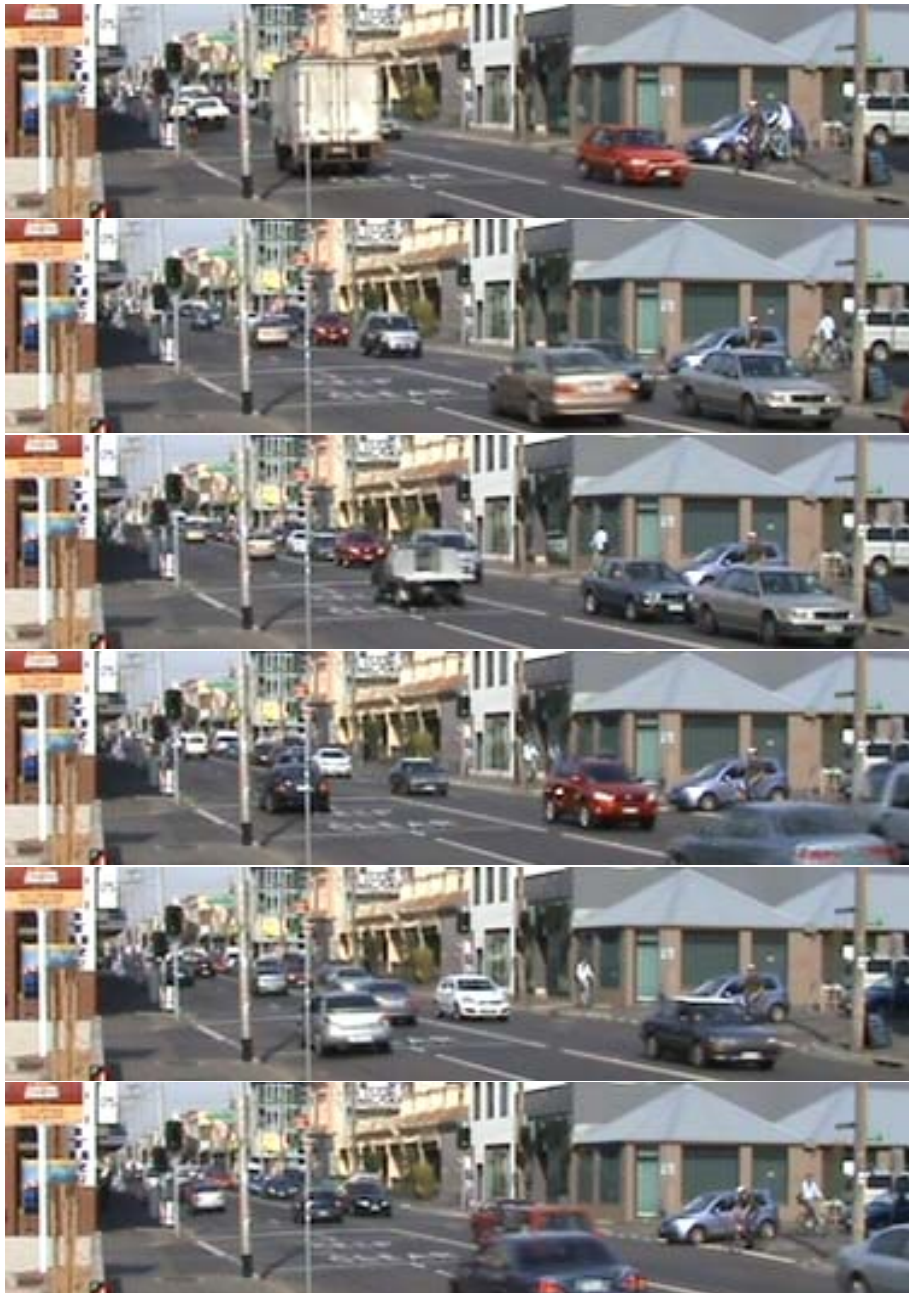
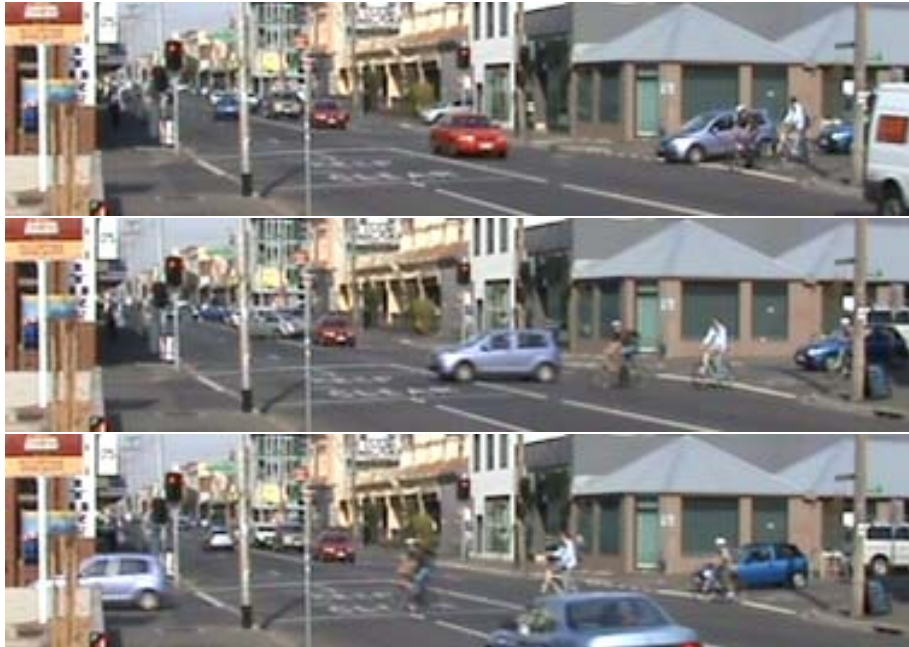
Figure 20 shows a cyclist who rode across to the crossing, pressed the button presumably trying to create a gap in traffic and then returned to Napier Street. The cyclist then crossed in the gap created by the red light, riding in front of the eastbound traffic on Johnston Street.

- **Figure 20 Before signalisation: Cyclist triggers the pedestrian light then returns to Napier Street to wait for gap**

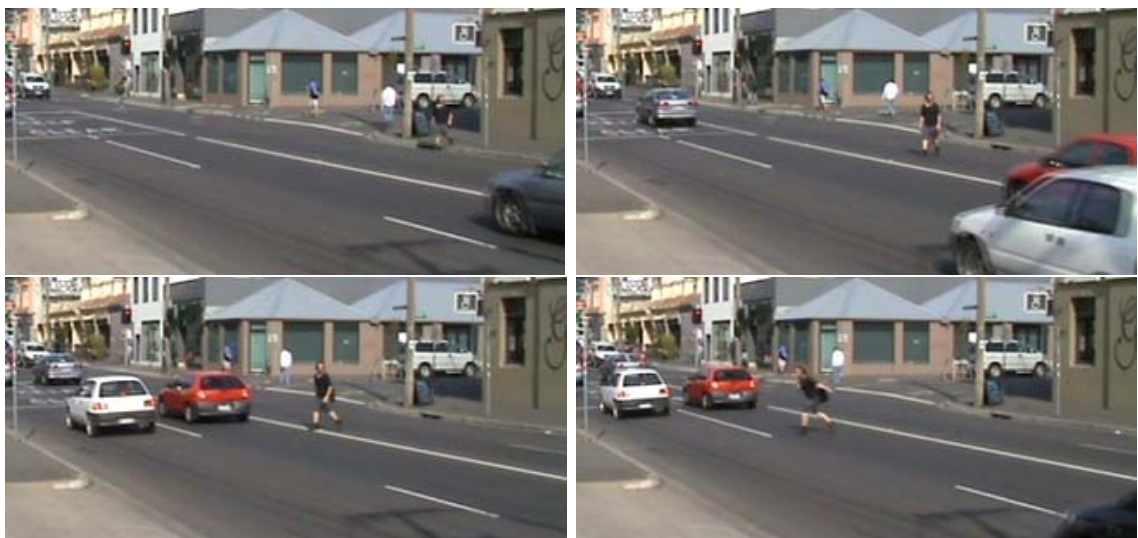
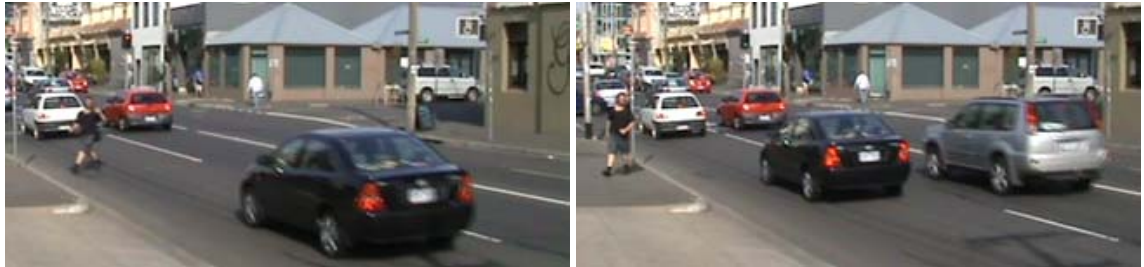
Figure 21 shows a pedestrian crossing away from the lights, forced to run to get across the road before the approaching car. After signalisation of the intersection, far fewer pedestrians were observed crossing in a gap, with almost all crossing at the designated pedestrian crosswalks and waiting for the green pedestrian signal.

- **Figure 21 Before signalisation: Pedestrian runs across Johnston Street in front of approaching car**

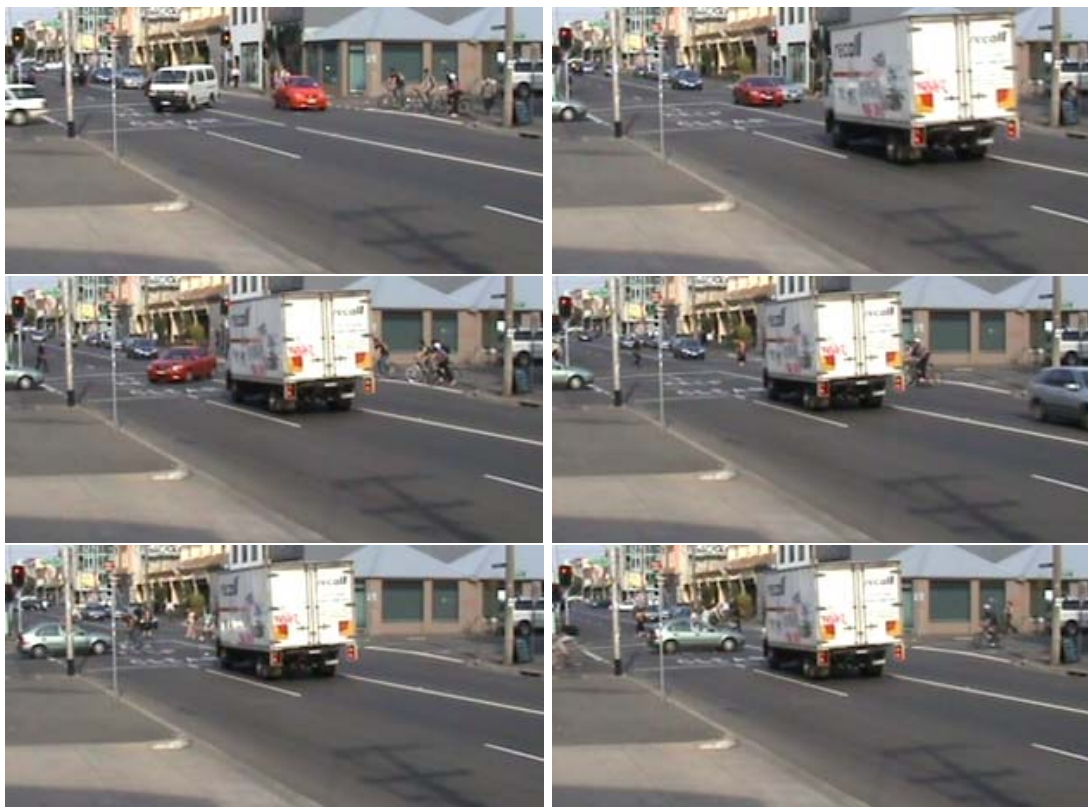
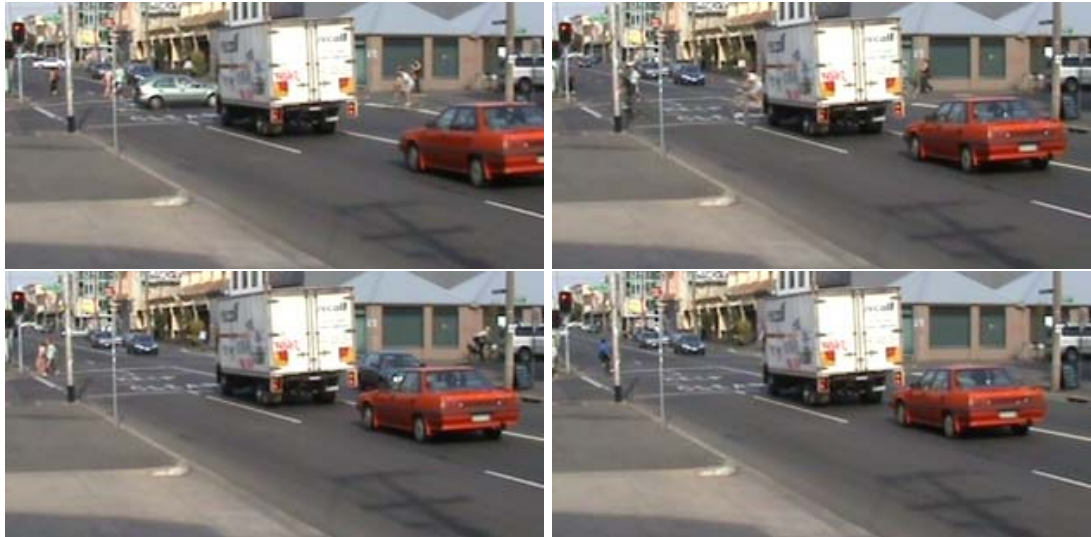
When the pedestrian crossing signal turned red to vehicles, cyclists and drivers had to negotiate who was going first and where, with no clear priority. Sometimes eastbound drivers stopped behind the Keep Clear Zone, allowing cyclists and vehicles to cross in front, and sometimes they would go right up to the stop line at the signals. See Figure 22.

- **Figure 22 Before signalisation: Vehicles and cyclists negotiate when there were vehicles queued at a red light**

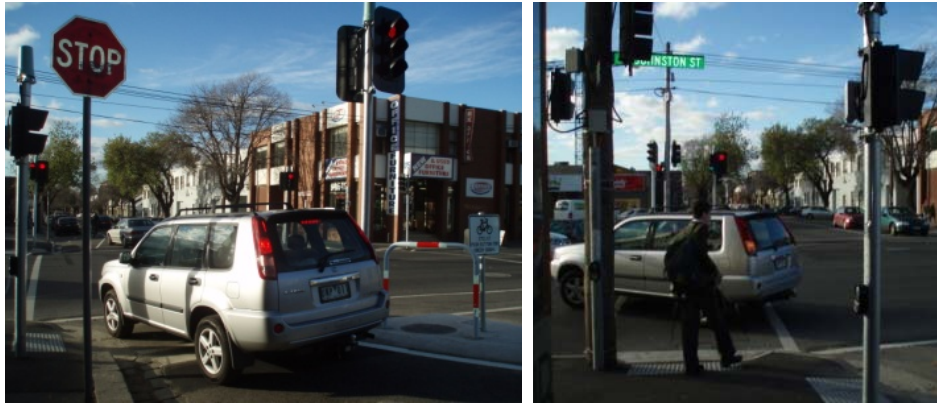
An unexpected observation made during the surveys was vehicles using the bicycle lane as a left turn slip lane. This was only observed twice – once during filming and once during the cyclist intercept surveys. Both instances were vehicles turning out of the south side of Napier Street, as shown in Figure 25 and Figure 26. Both appeared to be unaware that this was a bicycle lane rather than intentionally using the bicycle lane to avoid the signals. Since the time of the video surveys, bicycle symbols and green paint have been installed in the bicycle lane on the intersection approach. Drivers may now be more aware that this lane is for bicycles and not a left turn slip lane.

- **Figure 25 Vehicle using the northbound bicycle lane as a slip lane** (note vehicle going through red, presumably as they thought the lane was a slip lane, therefore the applicable law is give way. The stop sign also remains, reinforcing the notion of a slip lane.)

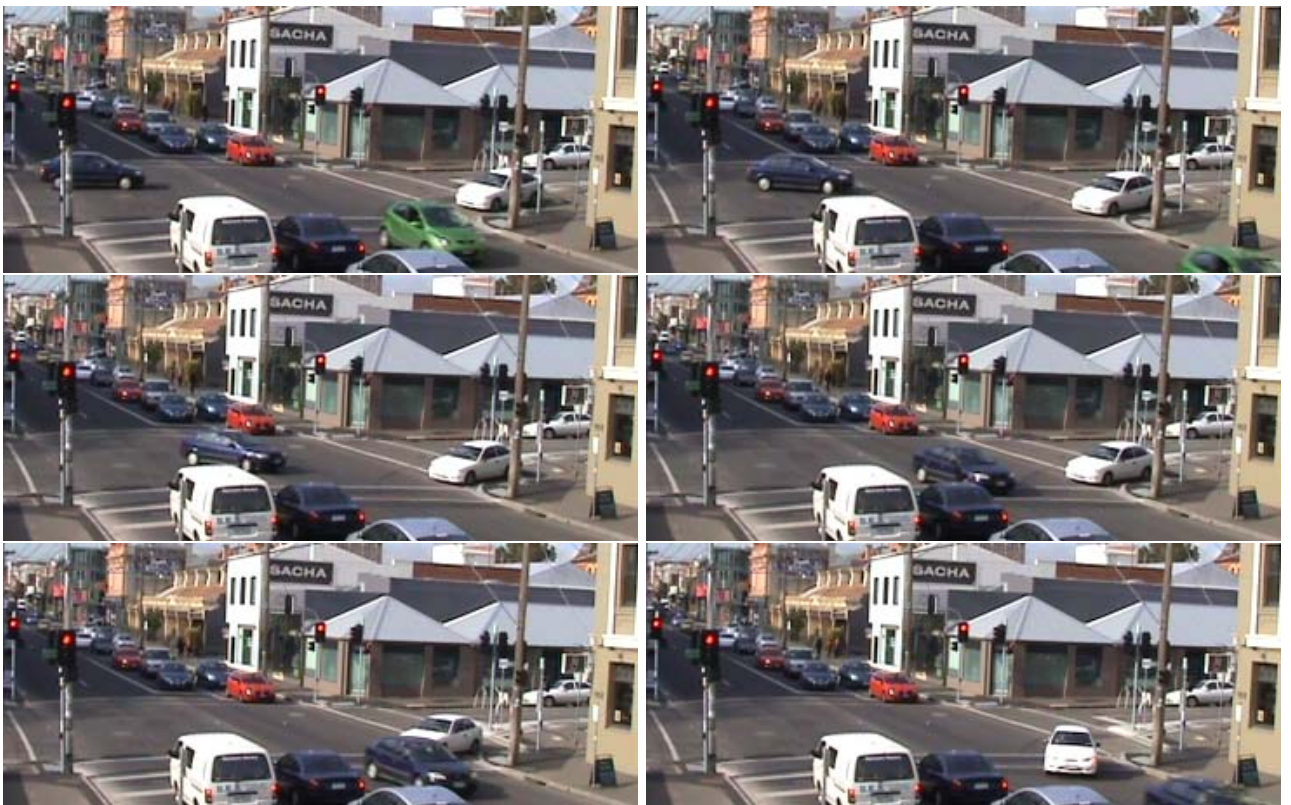
- **Figure 26 The white car on the right of the photo uses the bicycle lane as a left turn slip lane and gives way to the right turning blue vehicle**

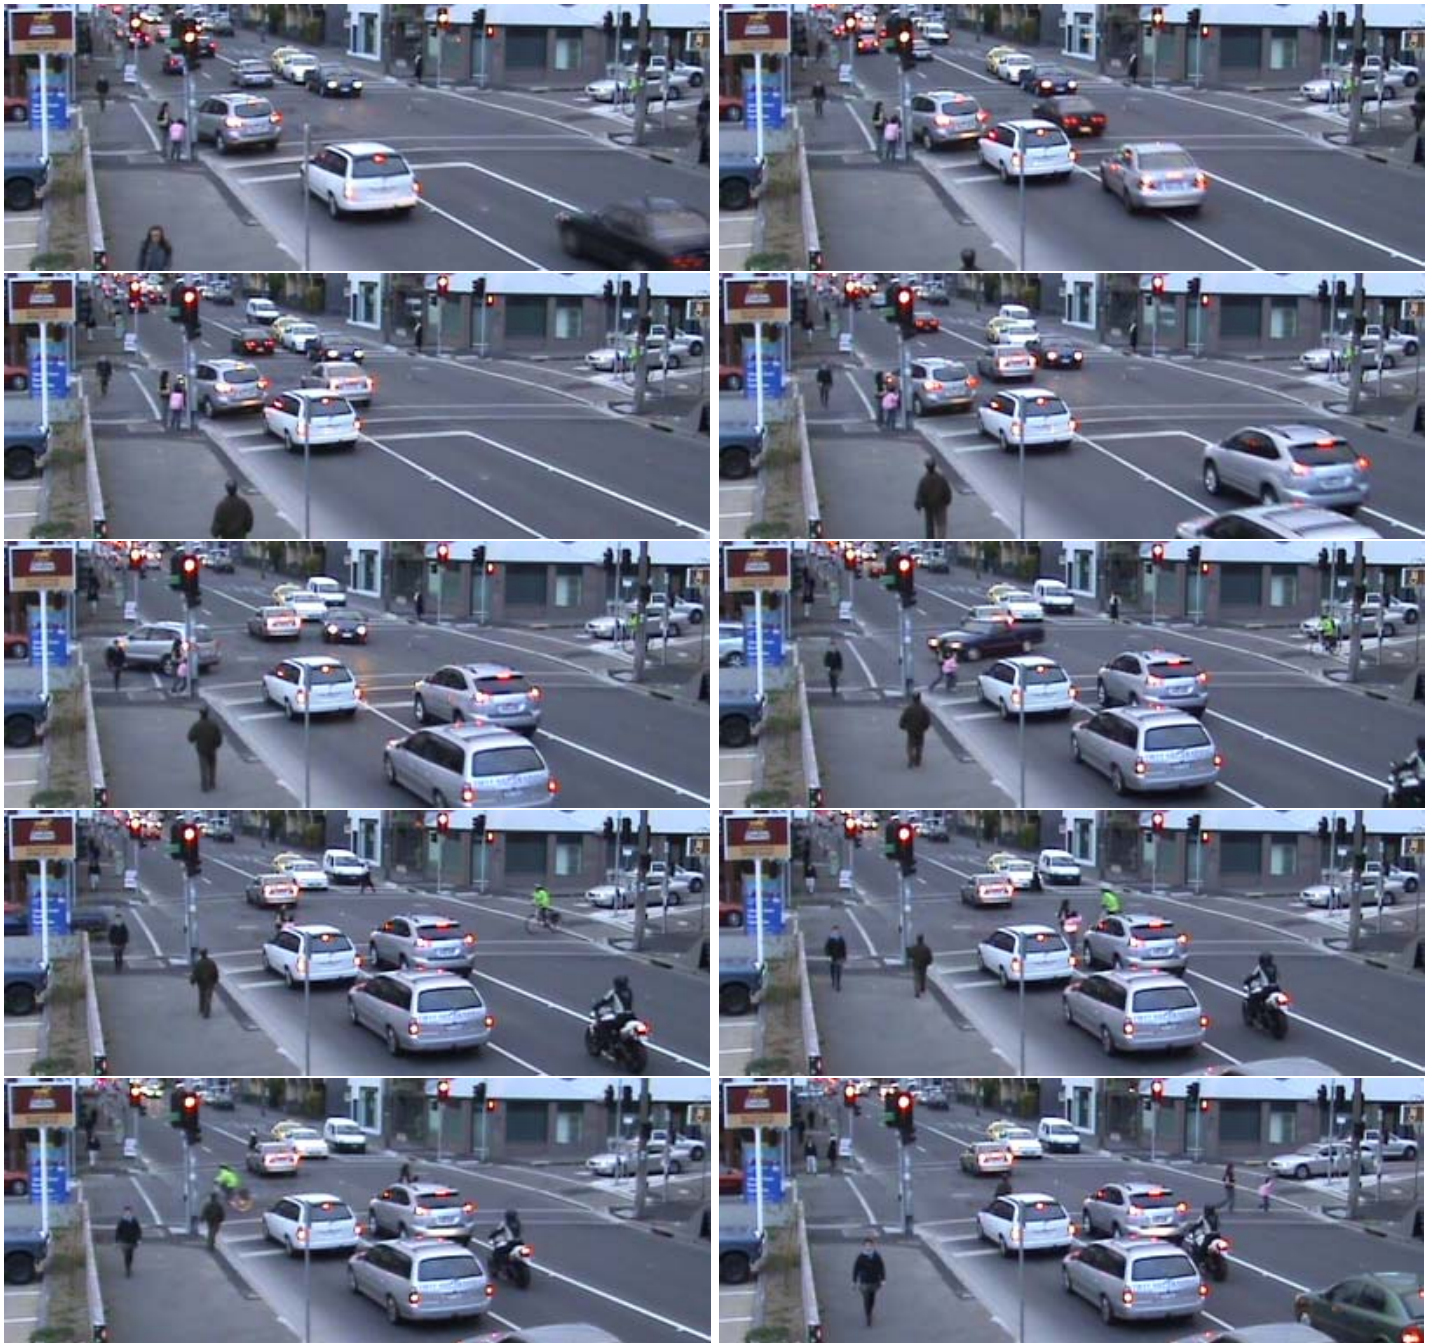
On several occasions, eastbound drivers were observed stopping at the far side pedestrian crossing (i.e. in the intersection). This is likely out of habit as this is the location of the previous pedestrian crossing and drivers would have been expecting signals at this location. We would expect that over

- **Figure 27 The silver car in the right lane stops at the far side pedestrian crosswalk (i.e. in the intersection)**

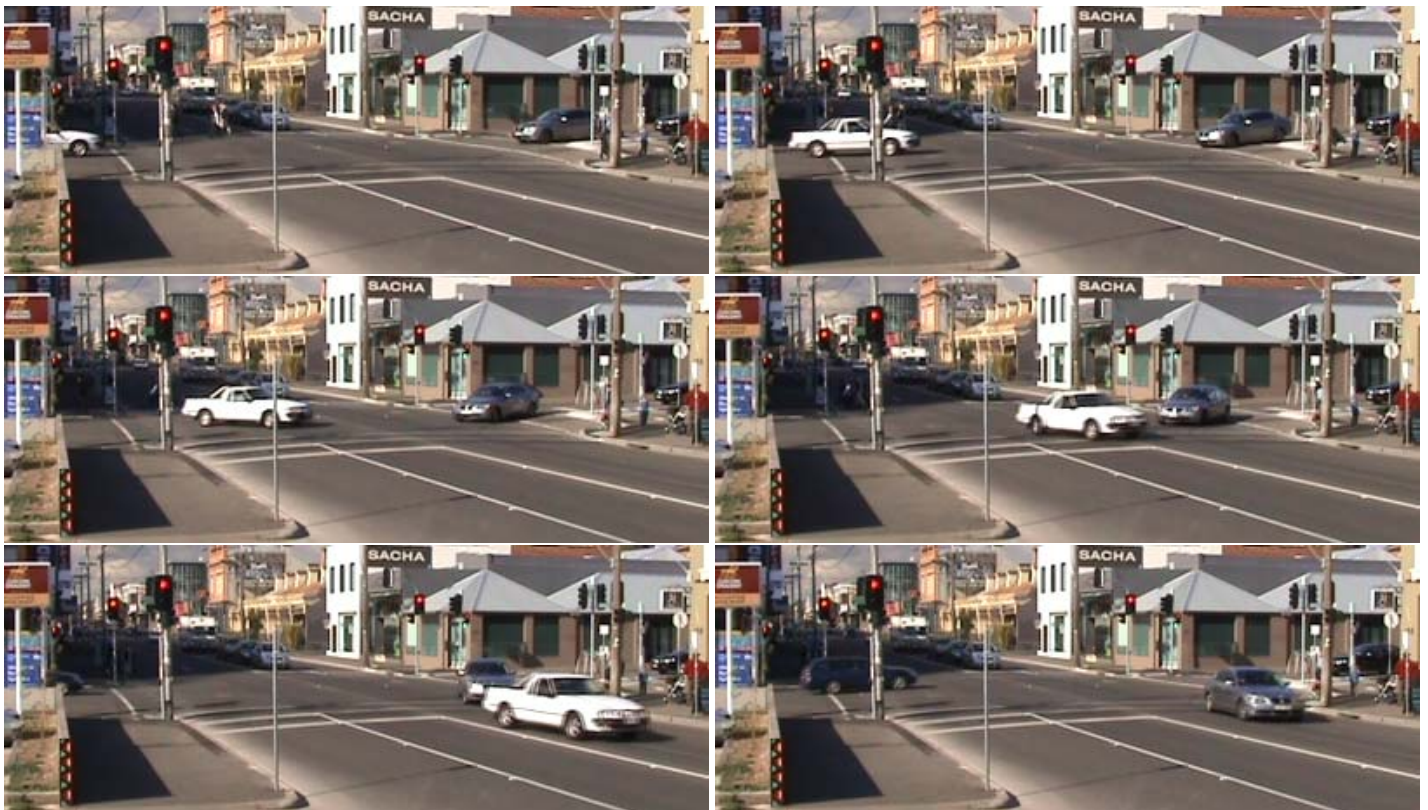
There were also a few instances of right turning vehicles turning *in front* of left turning vehicles as in Figure 28, which is opposite to the legal priority. This may have been due to uncertainty as to who had priority. Alternatively, as there was only a short time available to drivers out of Napier Street, drivers may have been impatient to get through the intersection and as such drove aggressively.

- **Figure 28 The right turning ute (incorrectly) forces priority over the left turning silver car**

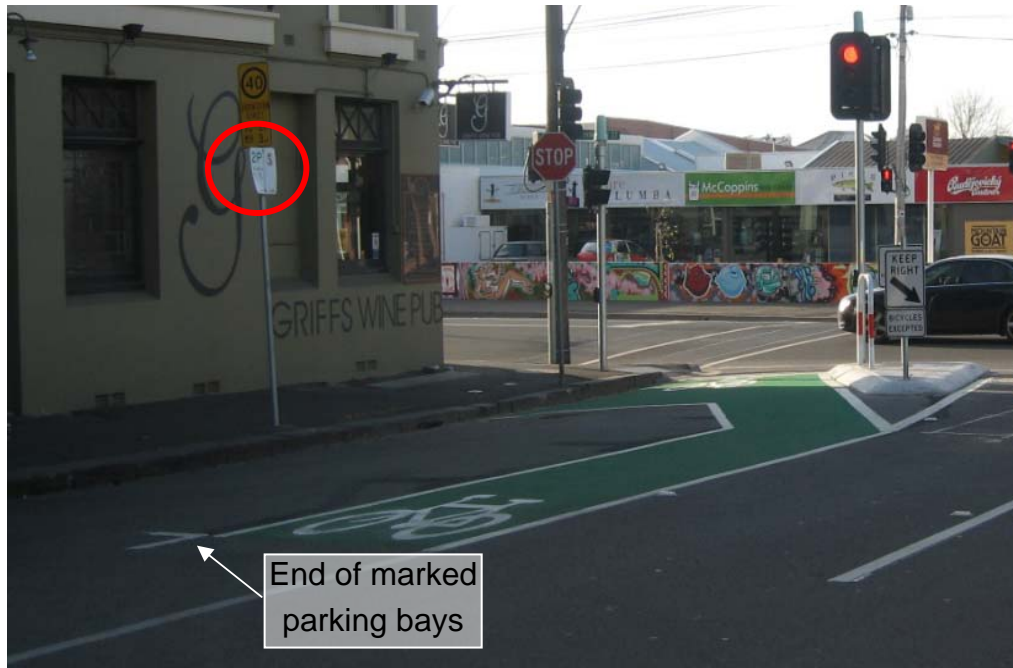
As of late August 2009, after which time the green paint and bicycle symbols had been installed, the parking signs in Napier Street south of Johnston Street still had not been relocated. The number of parking bays was reduced to improve visibility, and the line marking was changed accordingly, however the signage still had not been relocated, as in Figure 29.

- **Figure 29 Parking signs need to be relocated to match the reduction in parking bays**
